MALE (C T) ASSOCIATES SCHENECTADY NY F76 13713  
NATIONAL DAM INSPECTION PROGRAM. BLACK CREEK RESERVOIR DAM (NY --ETC(U)  
SEP 81 K J MALE DACW51-81-C-0014

REPORT DOCUMENTATION PAGE		READ INSTRUCTIONS BEFORE COMPLETING FORM
1. REPORT NUMBER	2. GOVT ACCESSION NO.	3. RECIPIENT'S CATALOG NUMBER
4. TITLE (and Subtitle) Phase I Inspection Report Black Creek Reservoir Mohawk River Basin, Herkimer County, NY Inventory No. 182	AD A109970	5. TYPE OF REPORT & PERIOD COVERED Phase I Inspection Report National Dam Safety Program

**MOHAWK RIVER BASIN  
TOWN OF NORWAY  
HERKIMER COUNTY, NEW YORK**

**BLACK CREEK  
RESERVOIR DAM  
NY 00182**

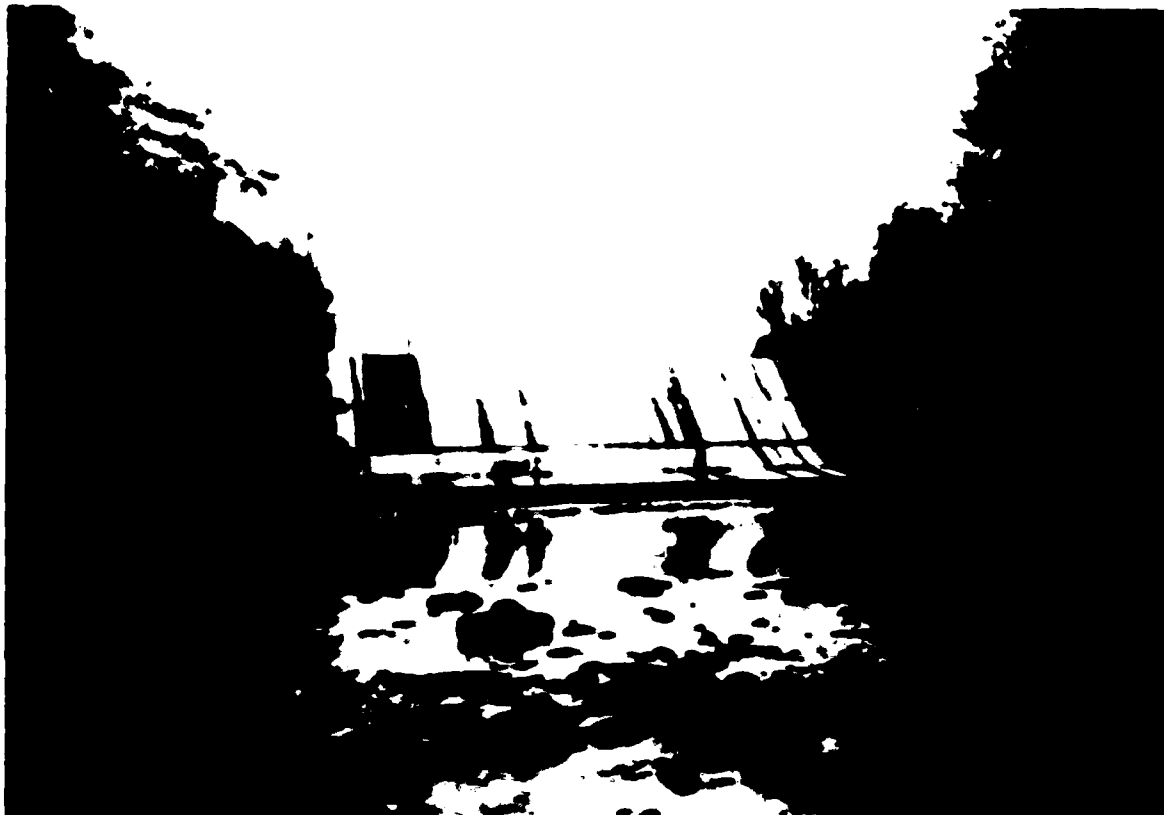
Overview Photo - Black Creek Reservoir Dam (spillway) - 6/3/81
